# Proposed Numurkah Flood Mitigation Project Stage 1 - Levee Construction, Numurkah, VIC 3636

Cultural Heritage Management Plan No: 19665

**Date:** 8/3/24

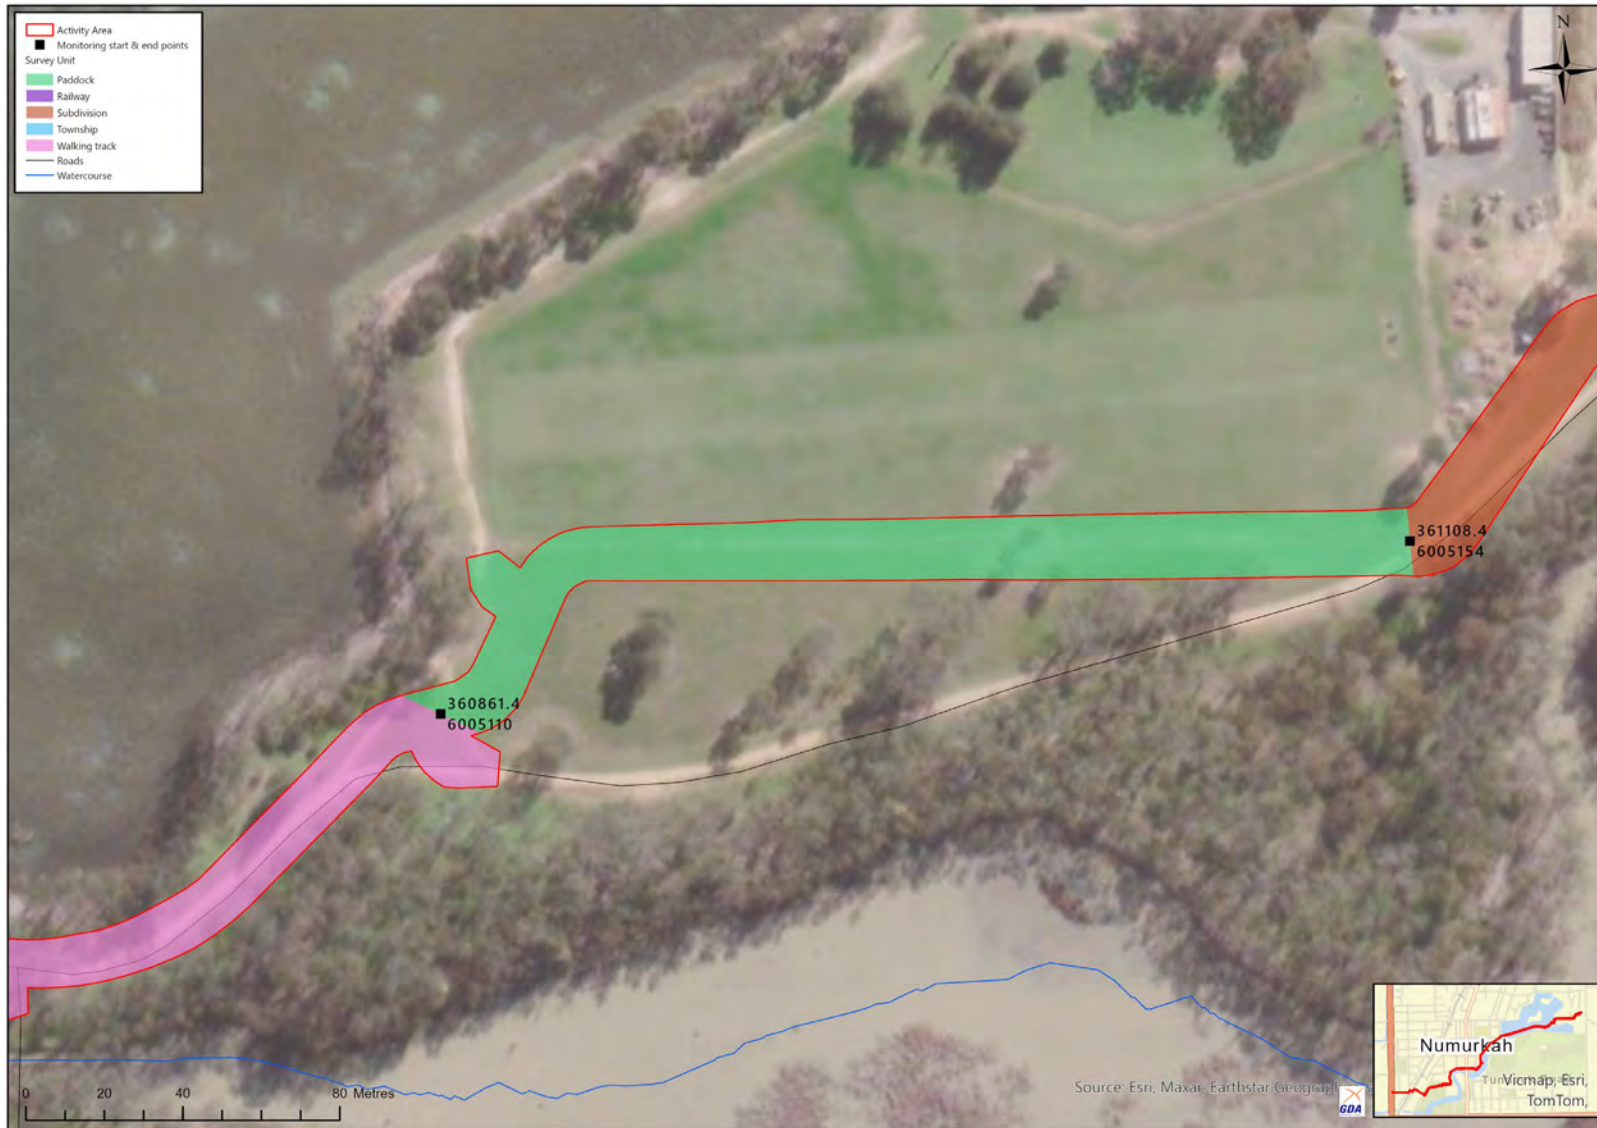
Map A: Survey Unit D monitoring start and end point (Management Condition 4-5). Scale 1:1,400.

1. Prior to commencing works within this section, the works zone must be sprayed and mown (if required) to clearly define the alignment through the mapped extent of Survey Unit D shown in **Map A**;
2. The works zone must be highlighted on all construction plans as a 'ACH Management Zone' and all site personnel working in this zone must have completed the Cultural Heritage Induction (**Condition 1**);

One (1) inspection must be undertaken within the Activity area by a maximum of two (2) representatives of YYNAC after works have been completed within the area shown in **Map A**. During the pedestrian survey, if any artefact or other material is retrieved, all materials must be appropriately conserved in good quality conservation bags which are clearly labelled with location details using indelible pen. Each bag must be labelled with the Date, Project name, Site VAHR Number/Field Name, Transect ID and Depth at Recovery (in millimetres).

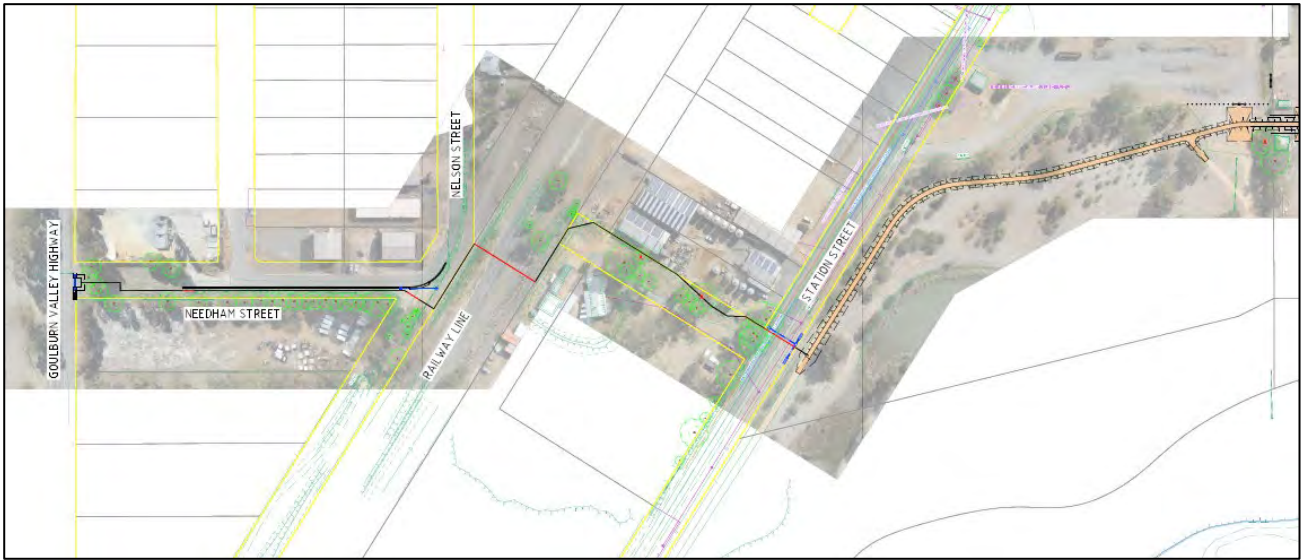
Figure 1A: Concept designs. Source: Moira Shire Council 2023

The proposed development will involve the disturbance of topsoil for the construction of the clay core and footings to a maximum depth 0.6m. This will involve mechanically excavating, scrapping and levelling the existing ground surface and importing of concrete and materials. It is anticipated that a bobcat and or 20t excavator will be used for excavation works, in addition to trucks and tippers for cartage. The proposed works will require ground disturbance within an already modified area. The use of areas containing existing infrastructure, will limit the degree of further ground disturbance to any ‘natural surfaces’ that may remain in the Activity area (**Figure 1A - 1D**).

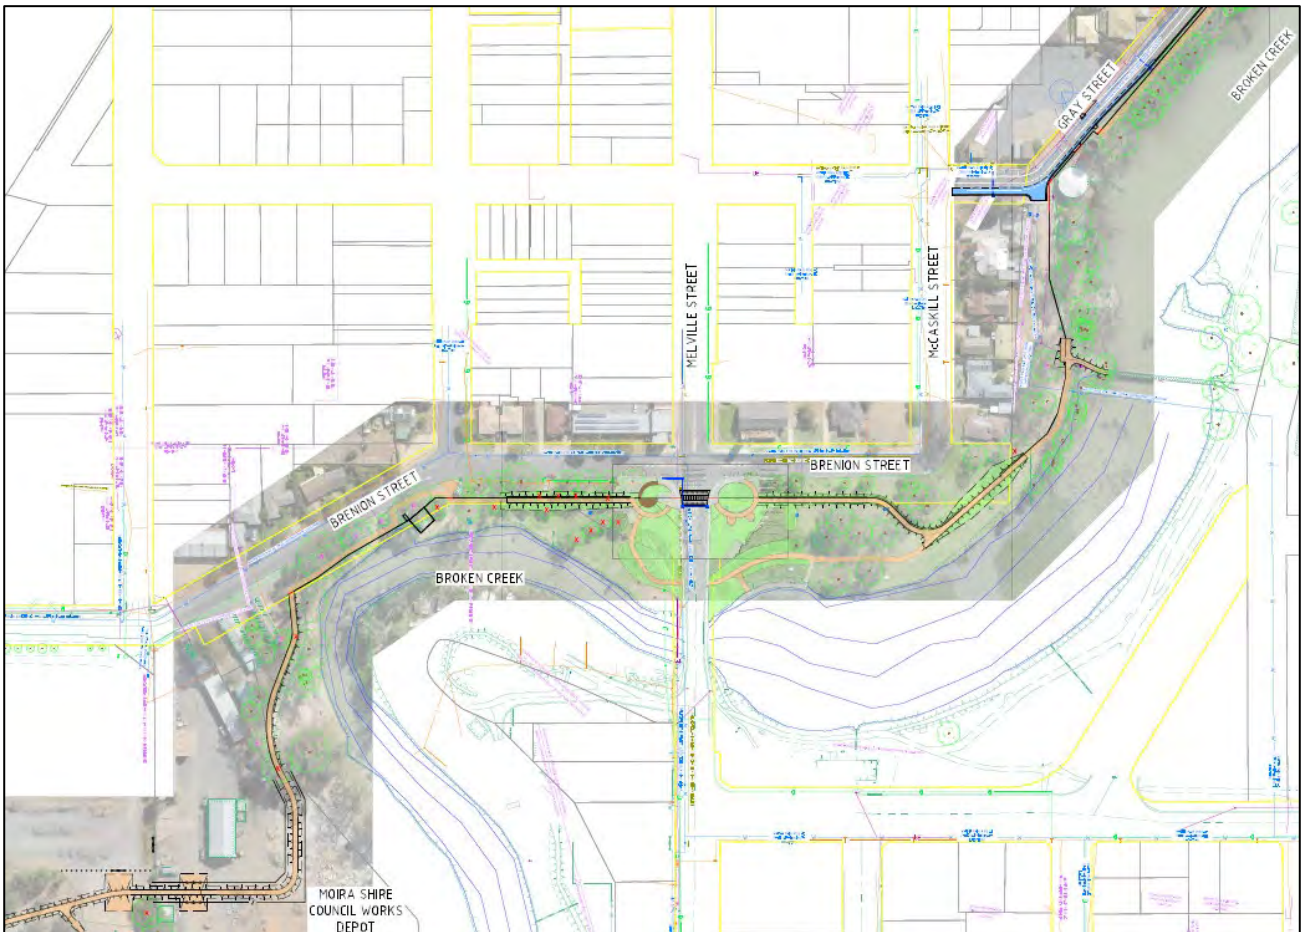
Figure 1B: Concept designs. Source: Moira Shire Council 2023

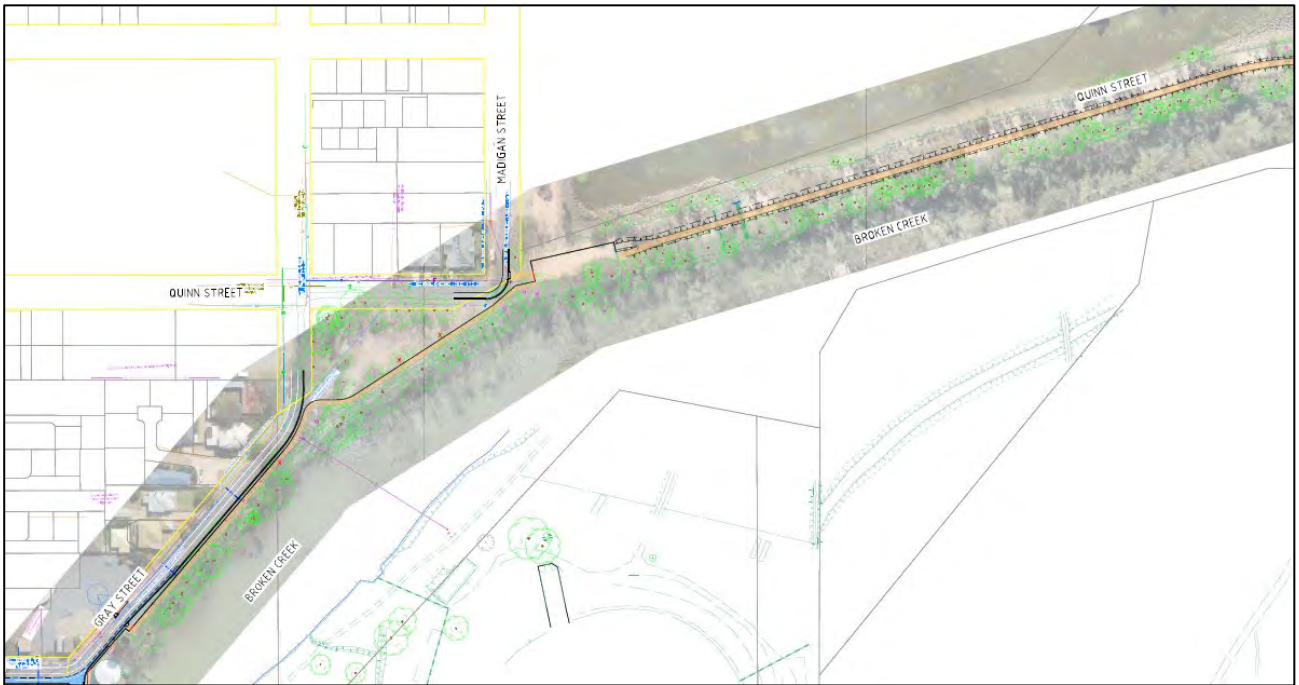
**Figure 1C: Concept designs. Source: Moira Shire Council 2023**

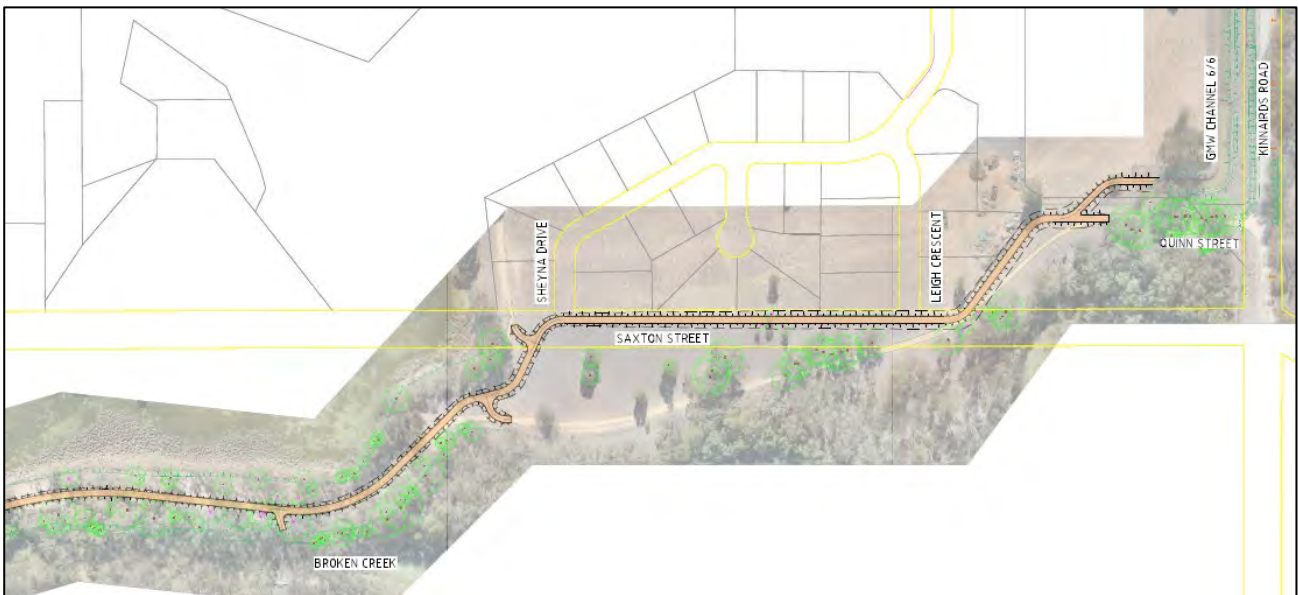
**Figure 1D: Concept designs. Source: Moira Shire Council 2023**

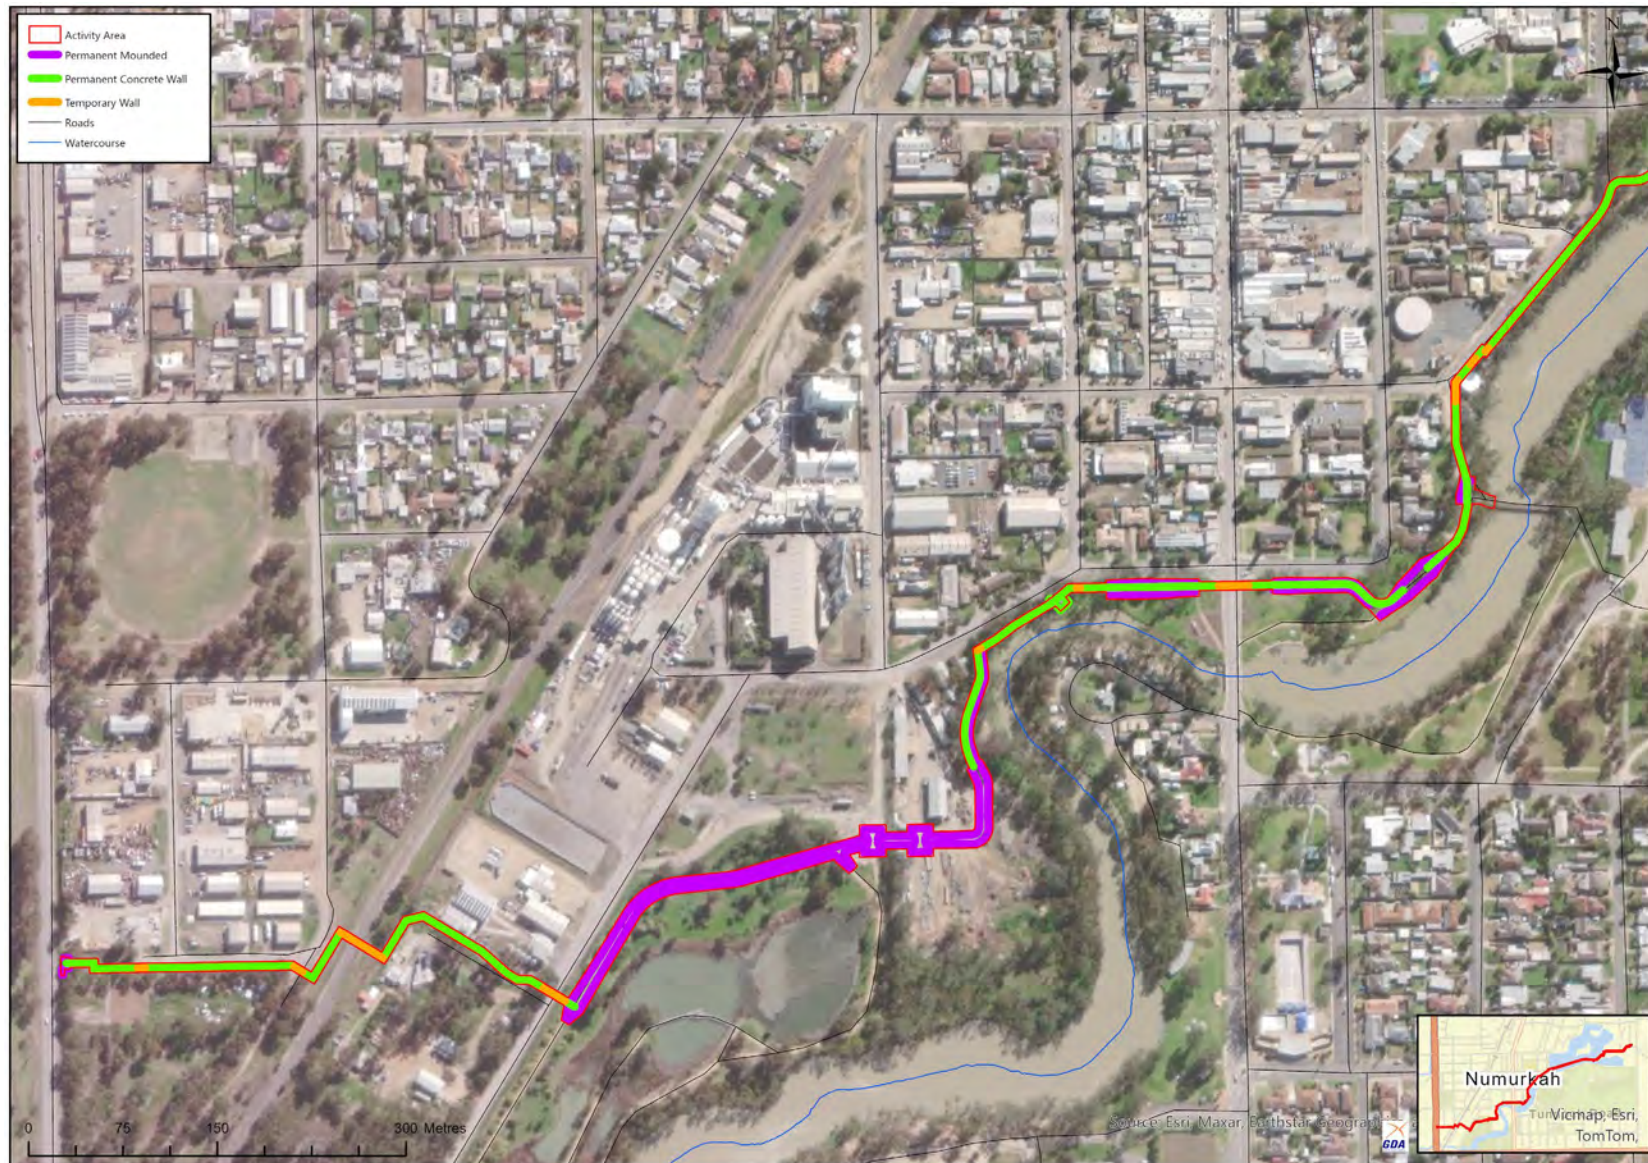
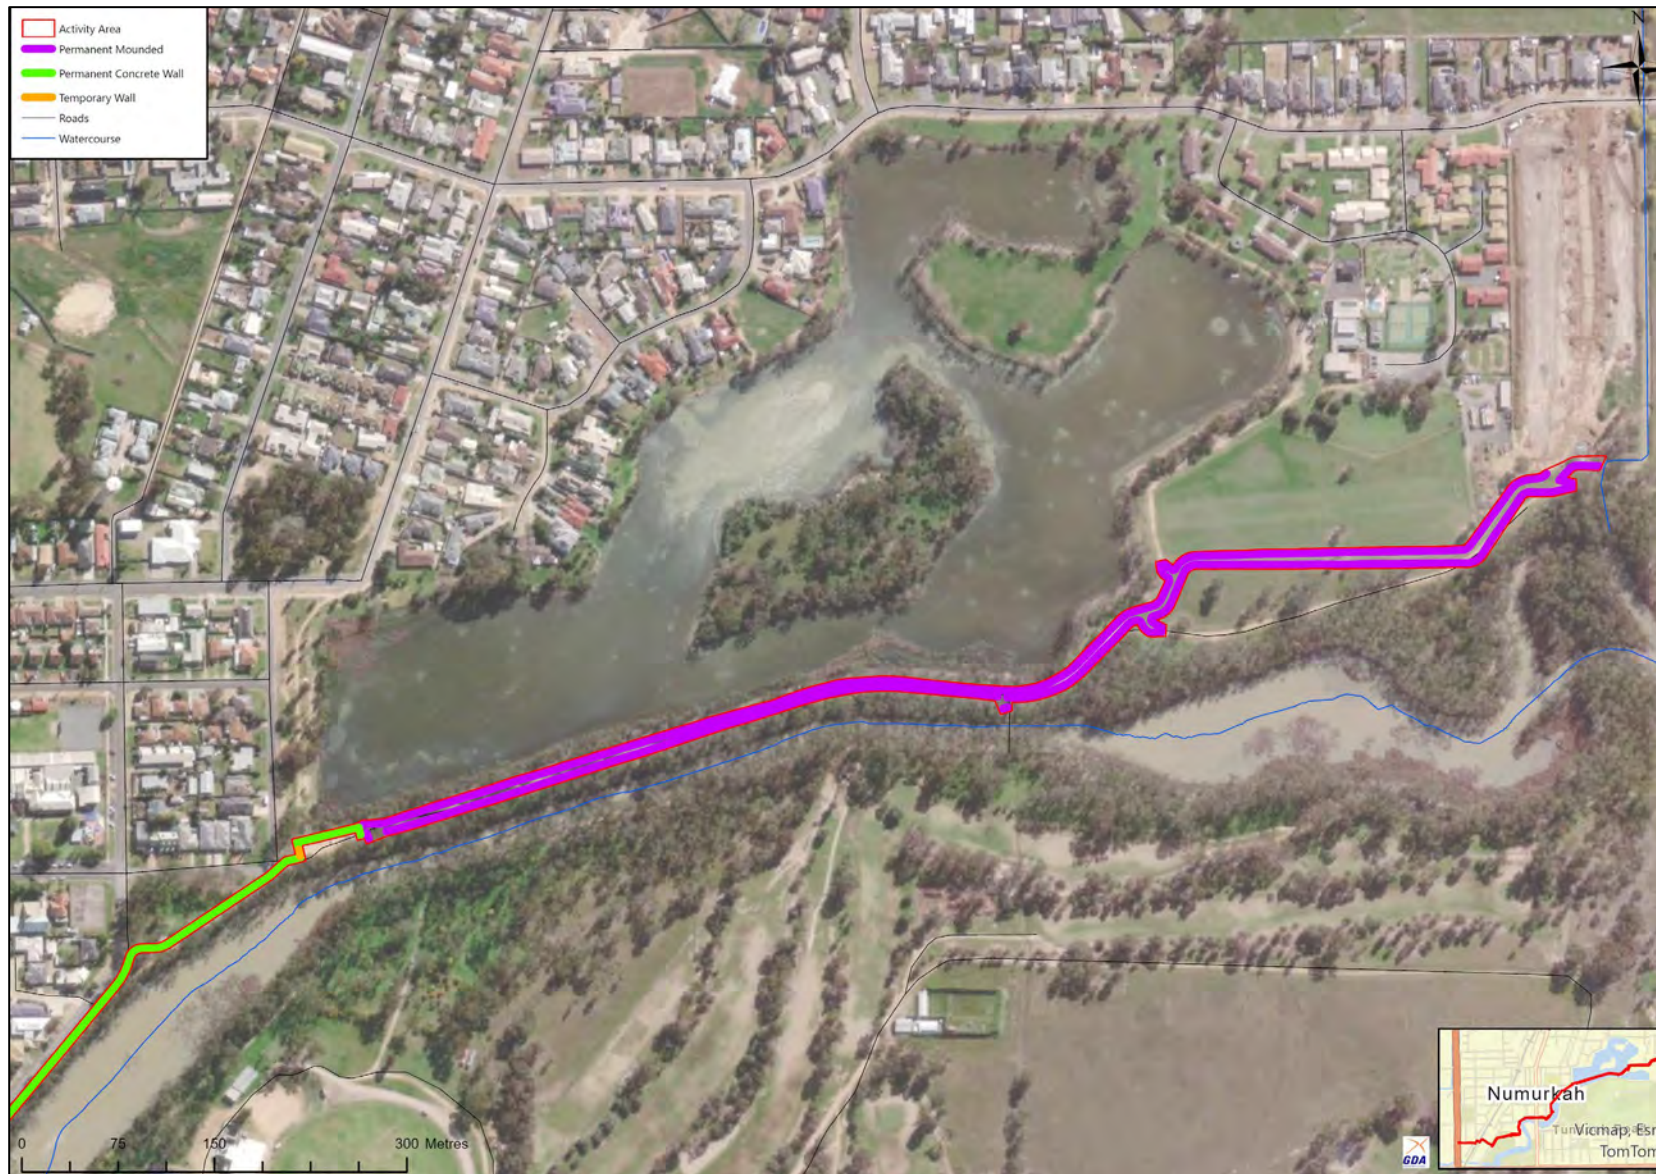
Map 2B: Proposed construction types of each section of the proposed levee. Source: Esri, 2024. Scale: 1:4,500

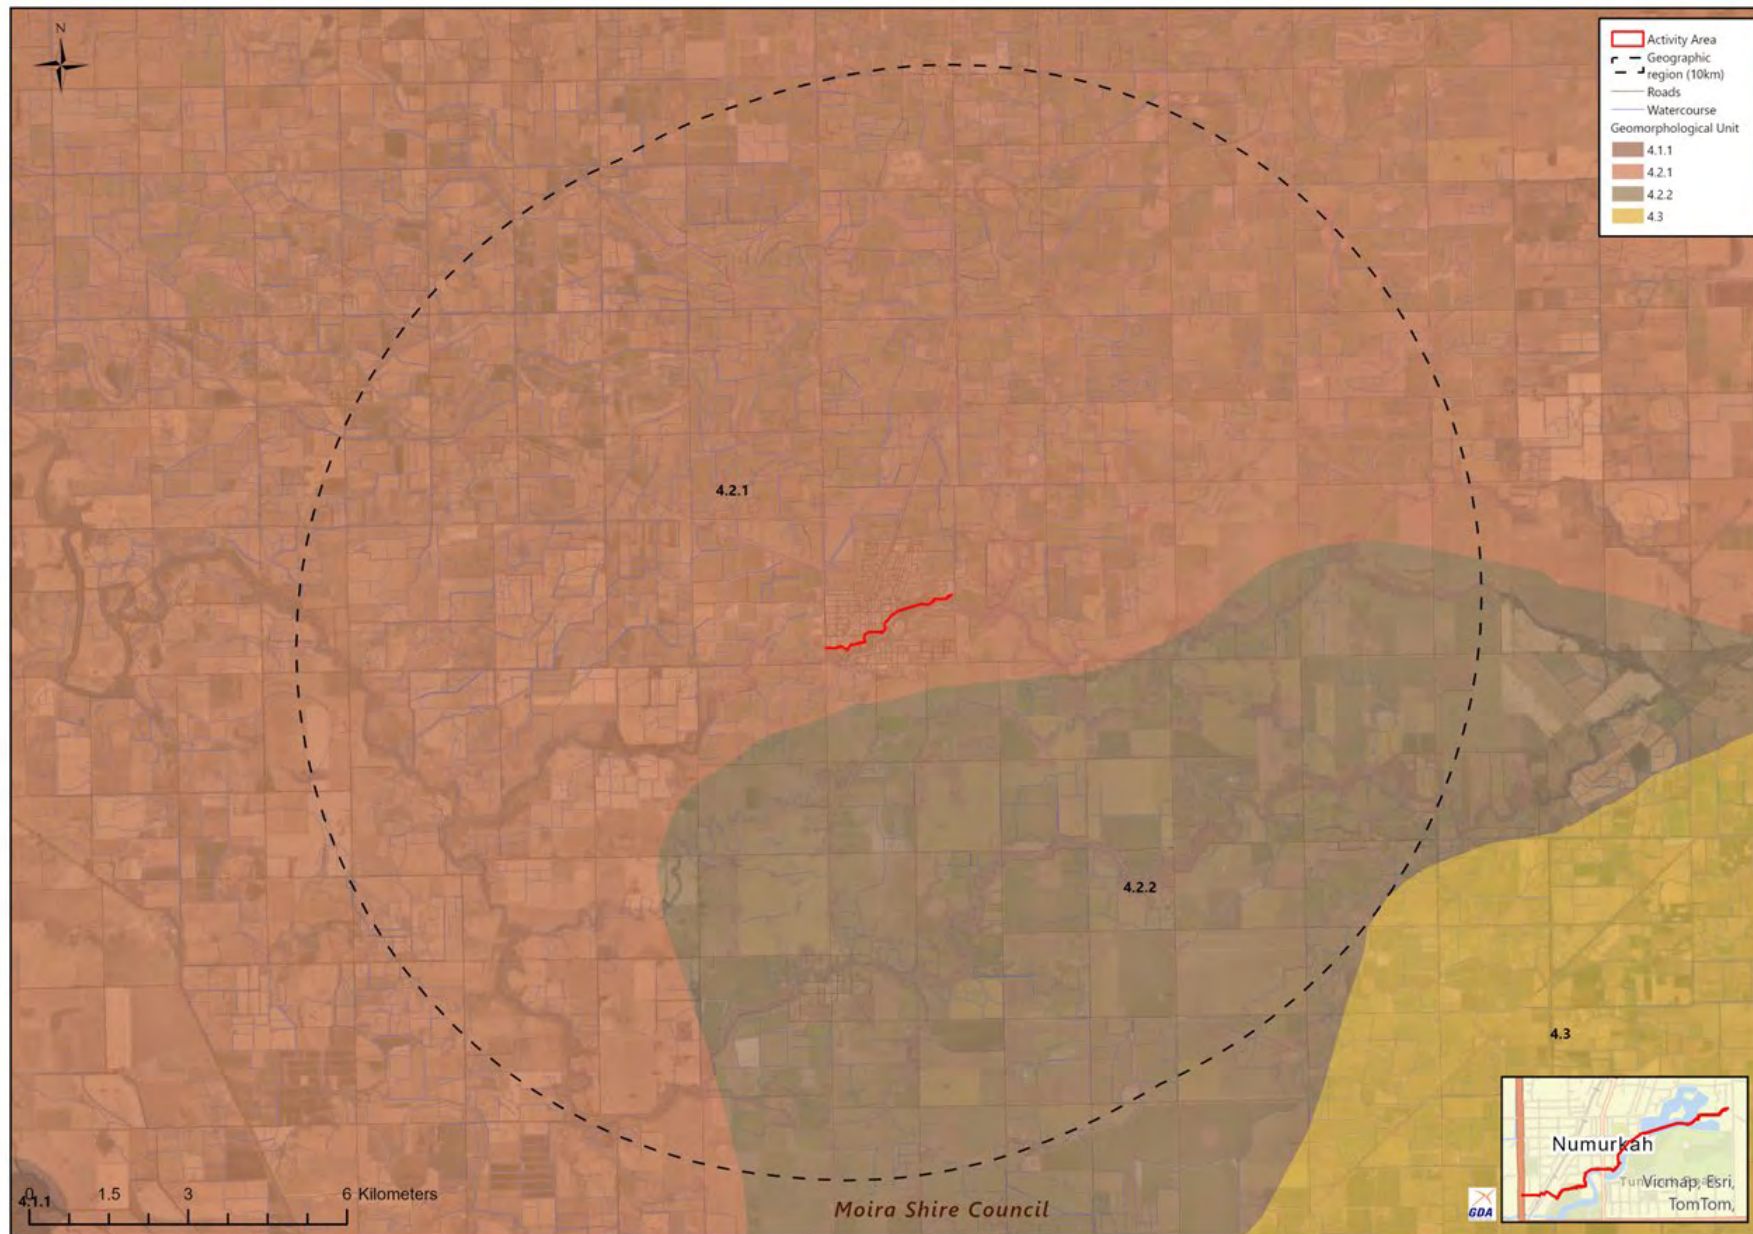
Map 4: Geomorphological units of the activity area and surrounding region. Source: Esri 2024. Scale: 1:113,000.

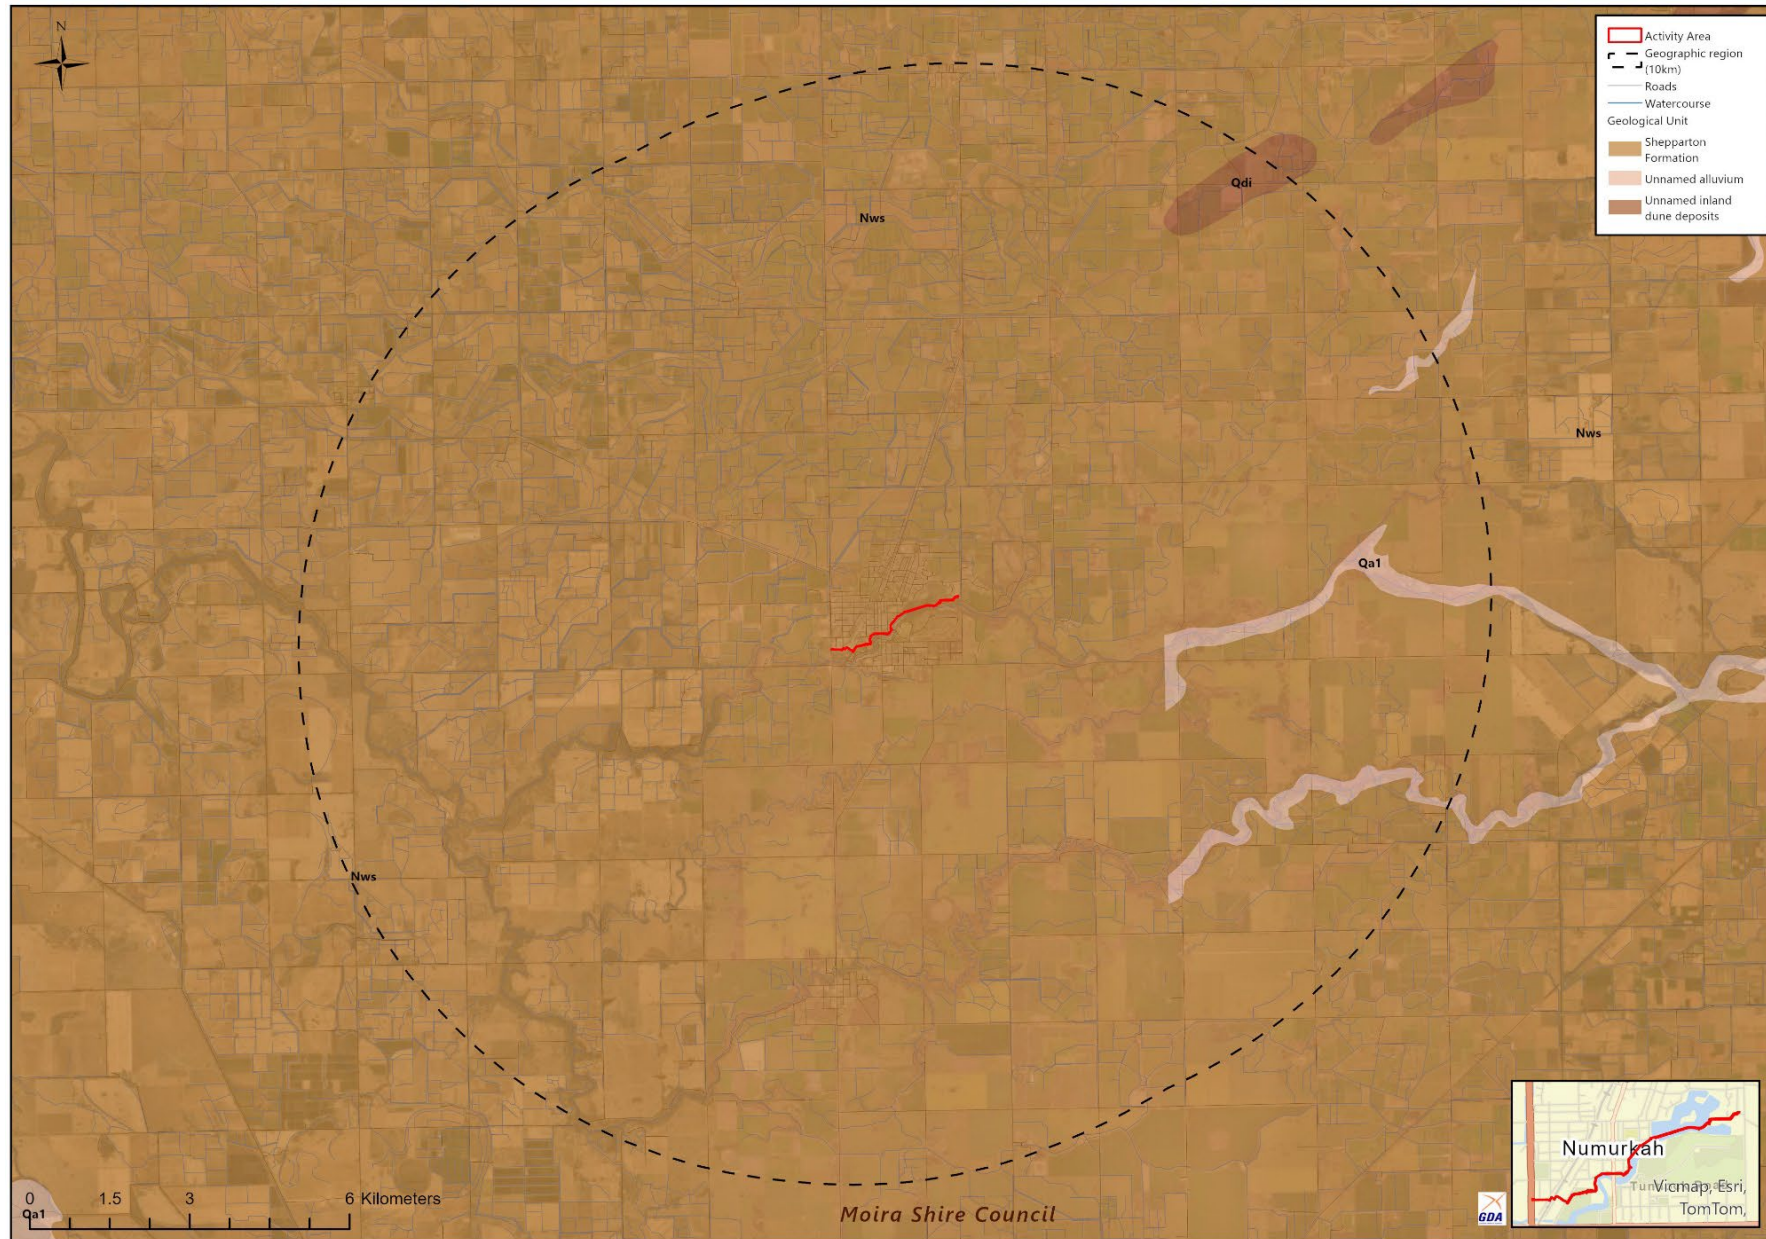
Map 5: Geology of the Activity area and surrounding region. Source: Esri 2024. Scale: 1:113,000.

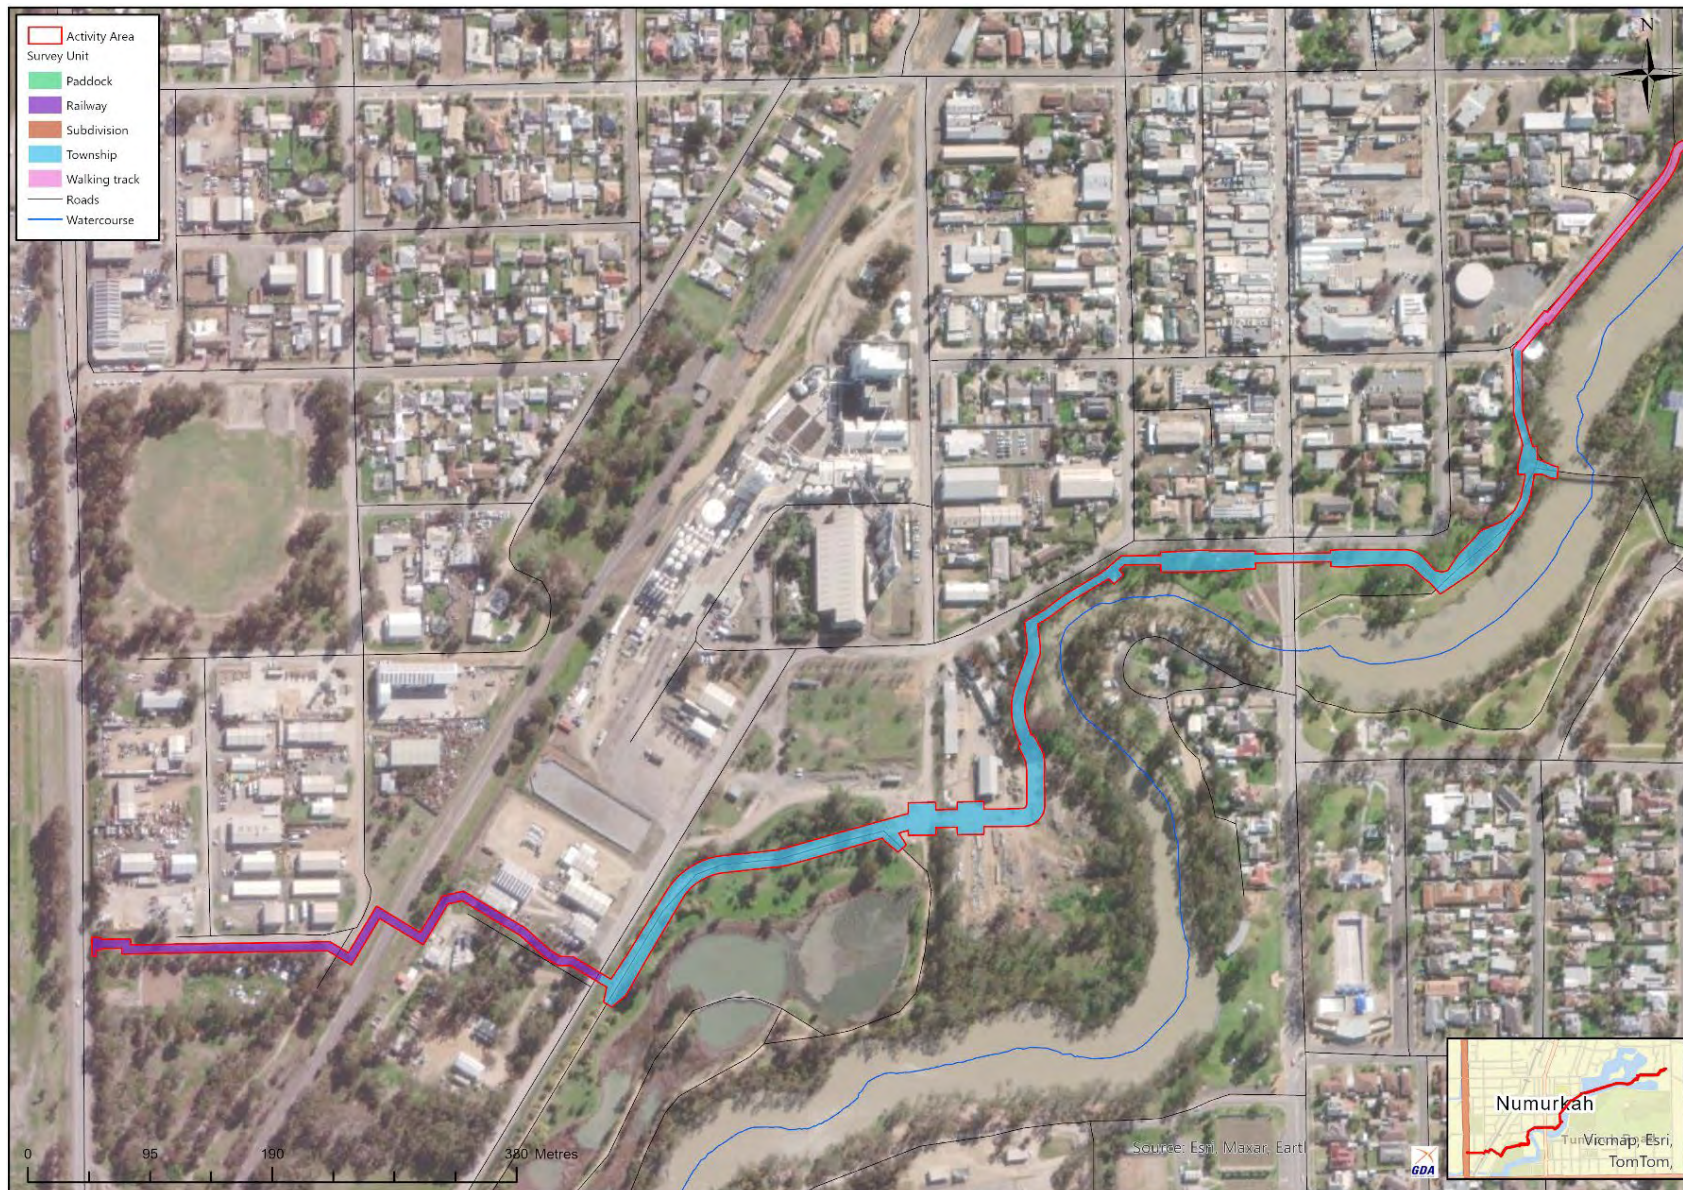
Map 8A: Survey Units in the Activity area. Scale 1: 4,500. Source: Esri 2023.

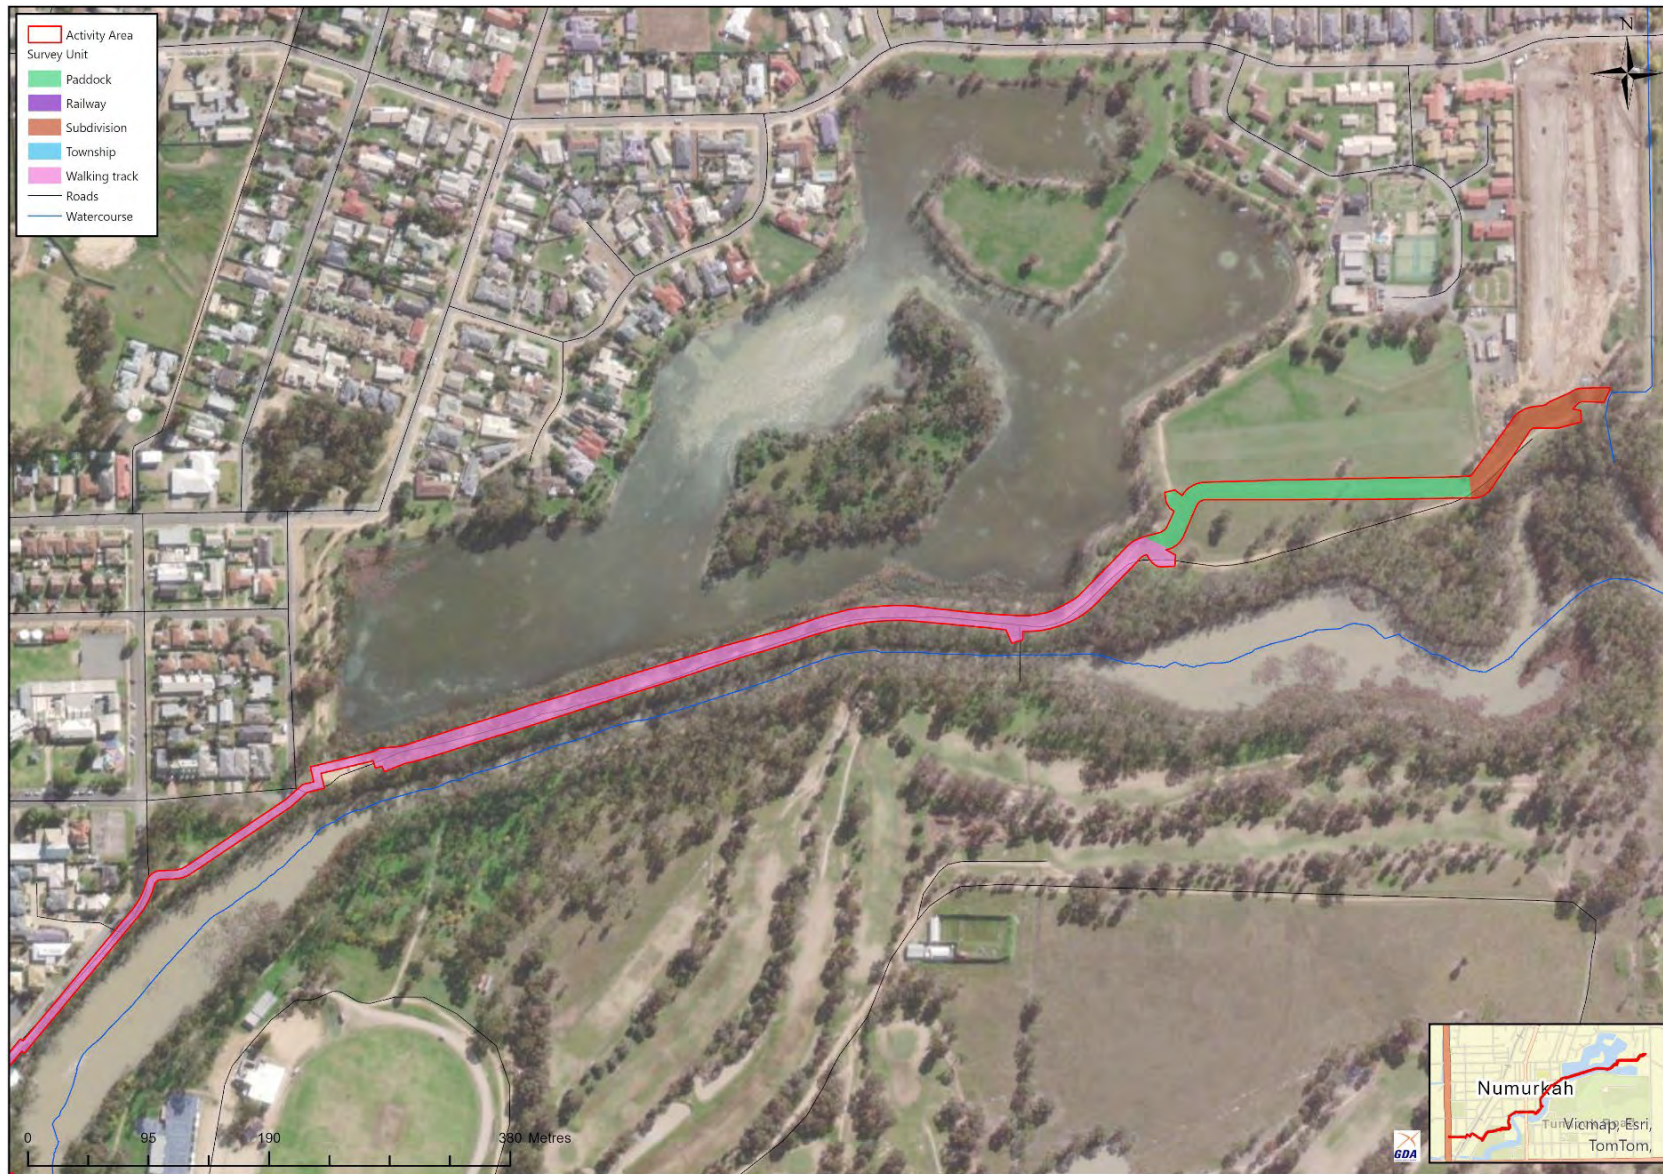
Map 8B: Survey Units in the Activity area. Scale 1: 4,500. Source: Esri 2023.

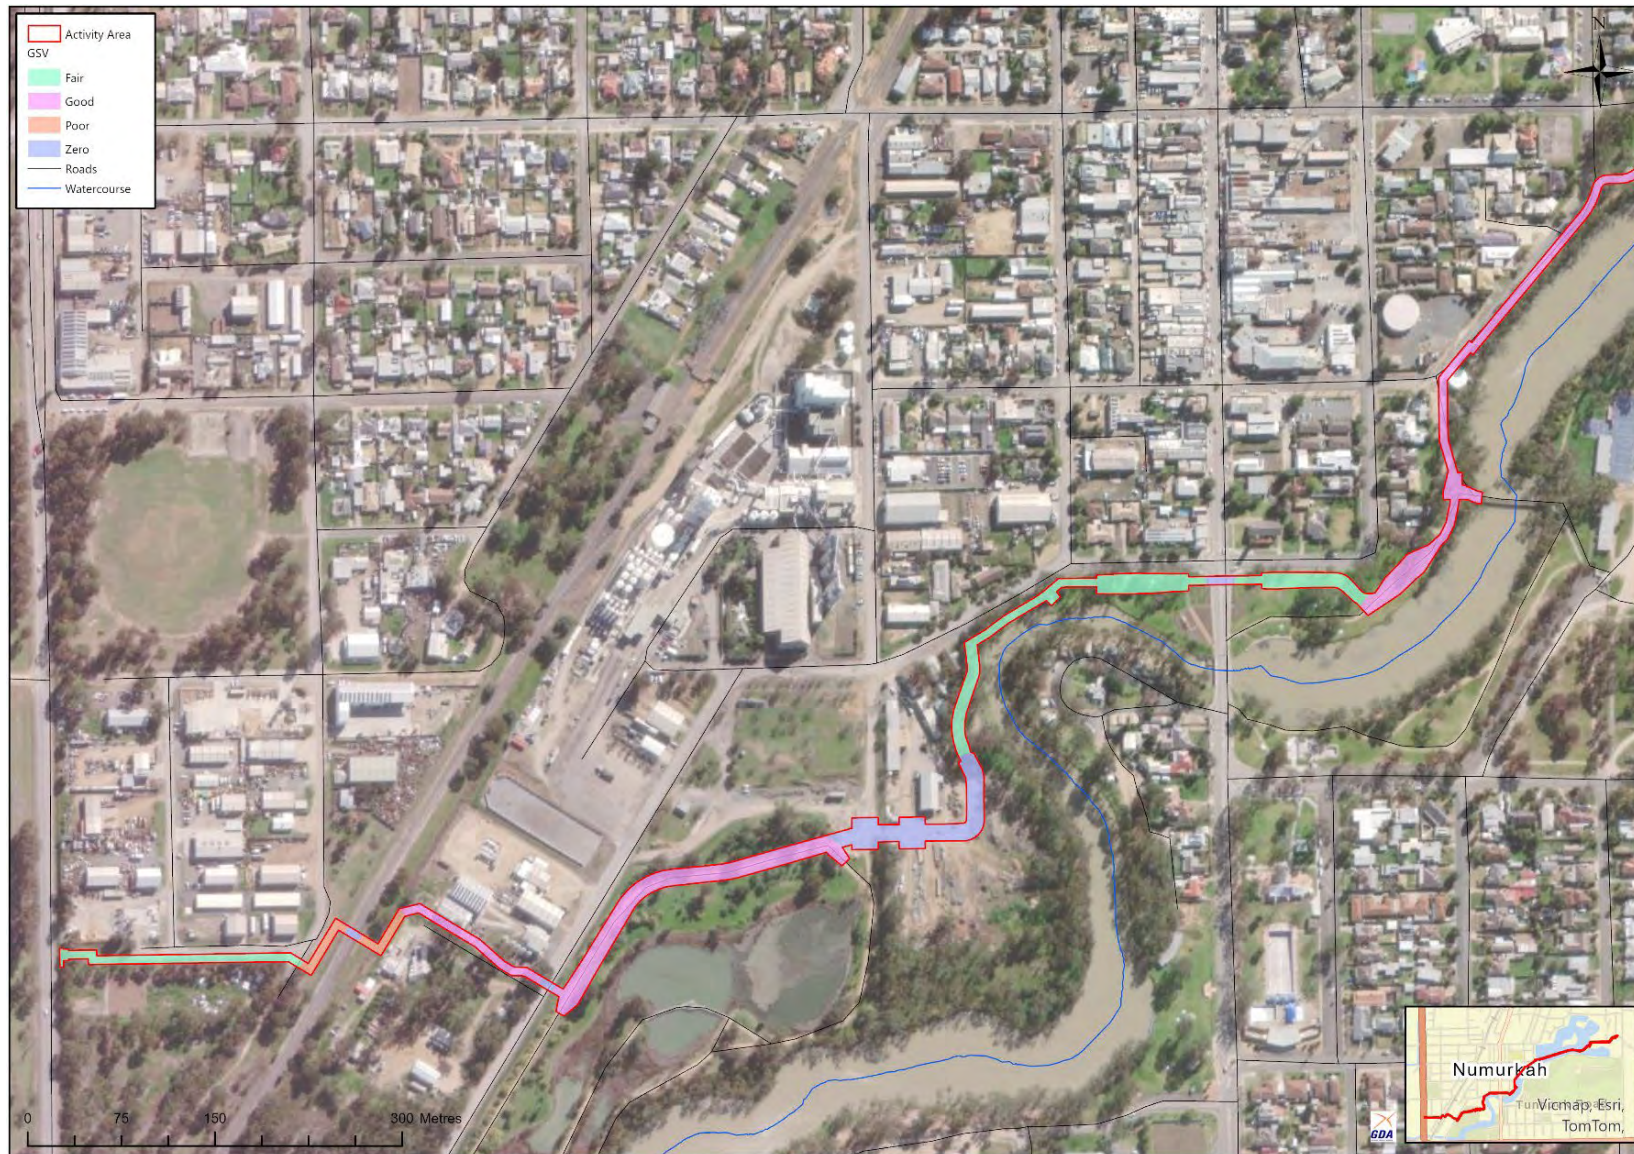
**Map 9A: Ground Surface Visibility in the Activity Area. Scale 1:4,500. Source: ESRI 2023**

Ground surface visibility encountered was variable ranging from areas of good visibility (50-70%) to poor (10-30%) in areas of mown exotic grasses, along with some areas with no/zero visibility due to sealed roads.

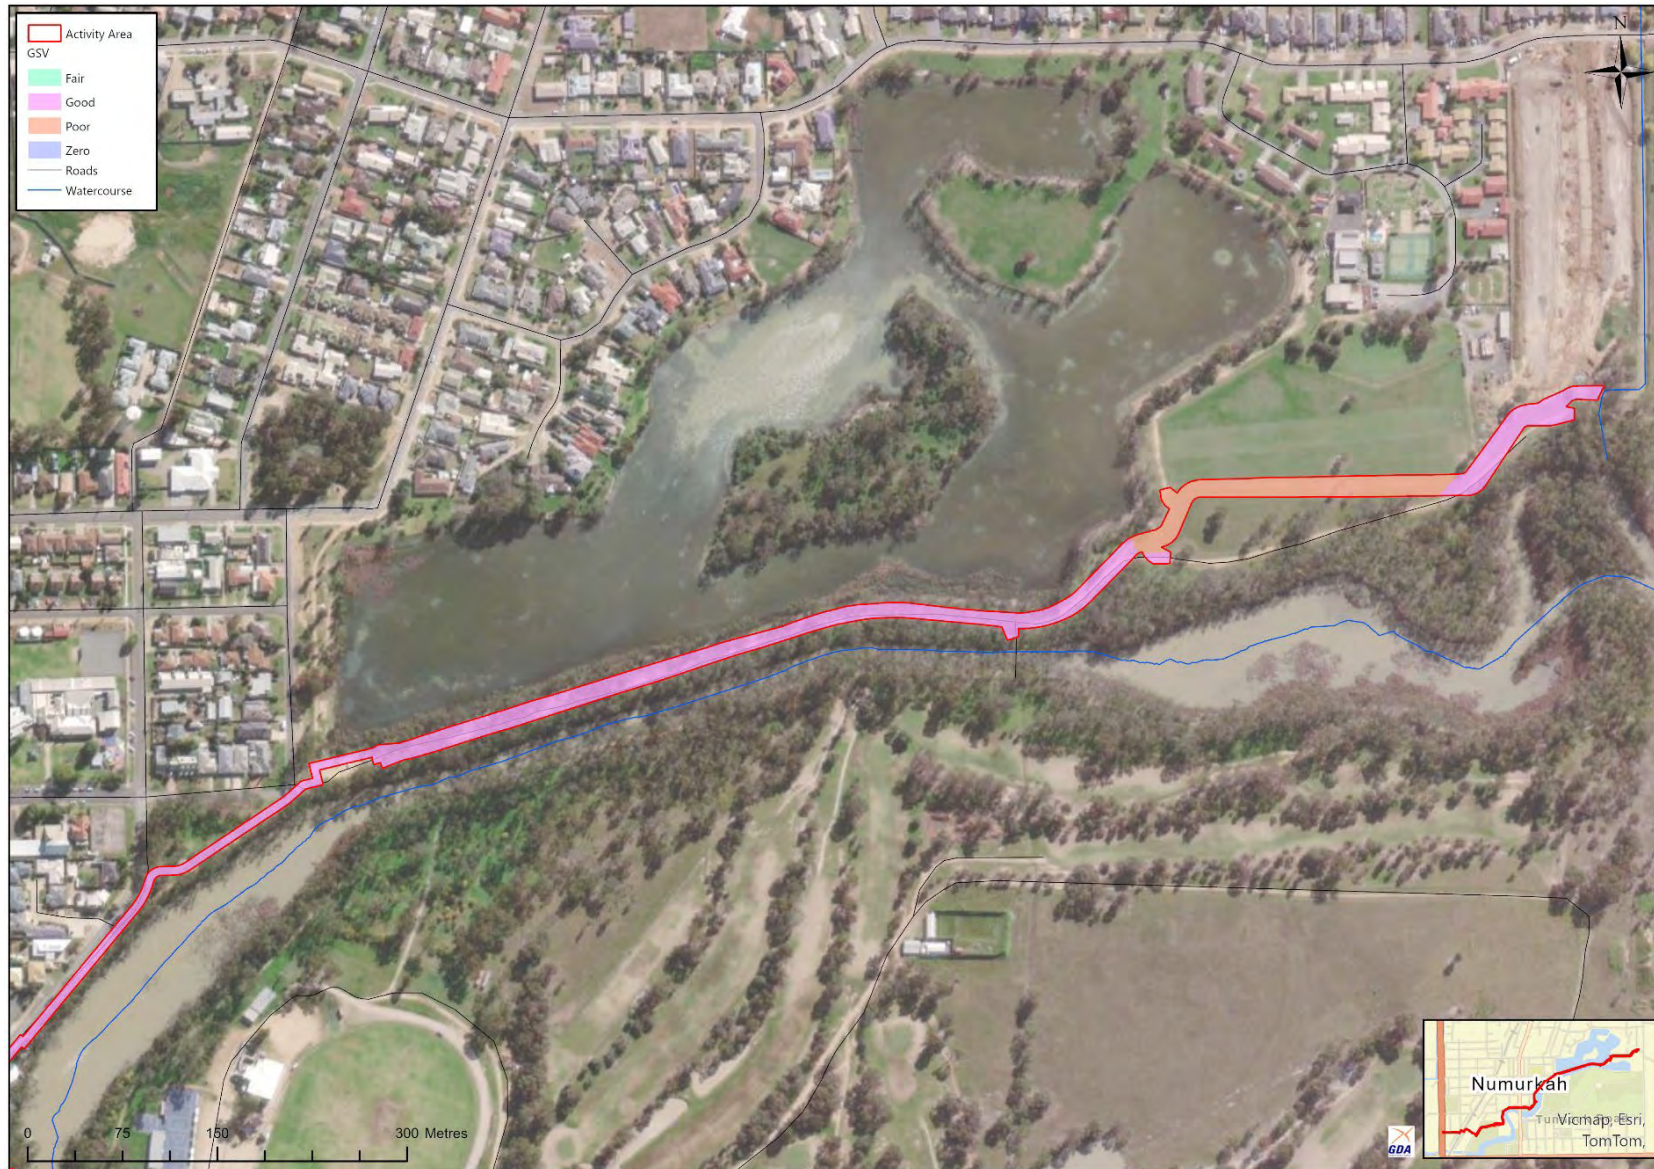
Map 9B: Ground Surface Visibility in the Activity Area. Scale 1:4,500. Source: ESRI 2023

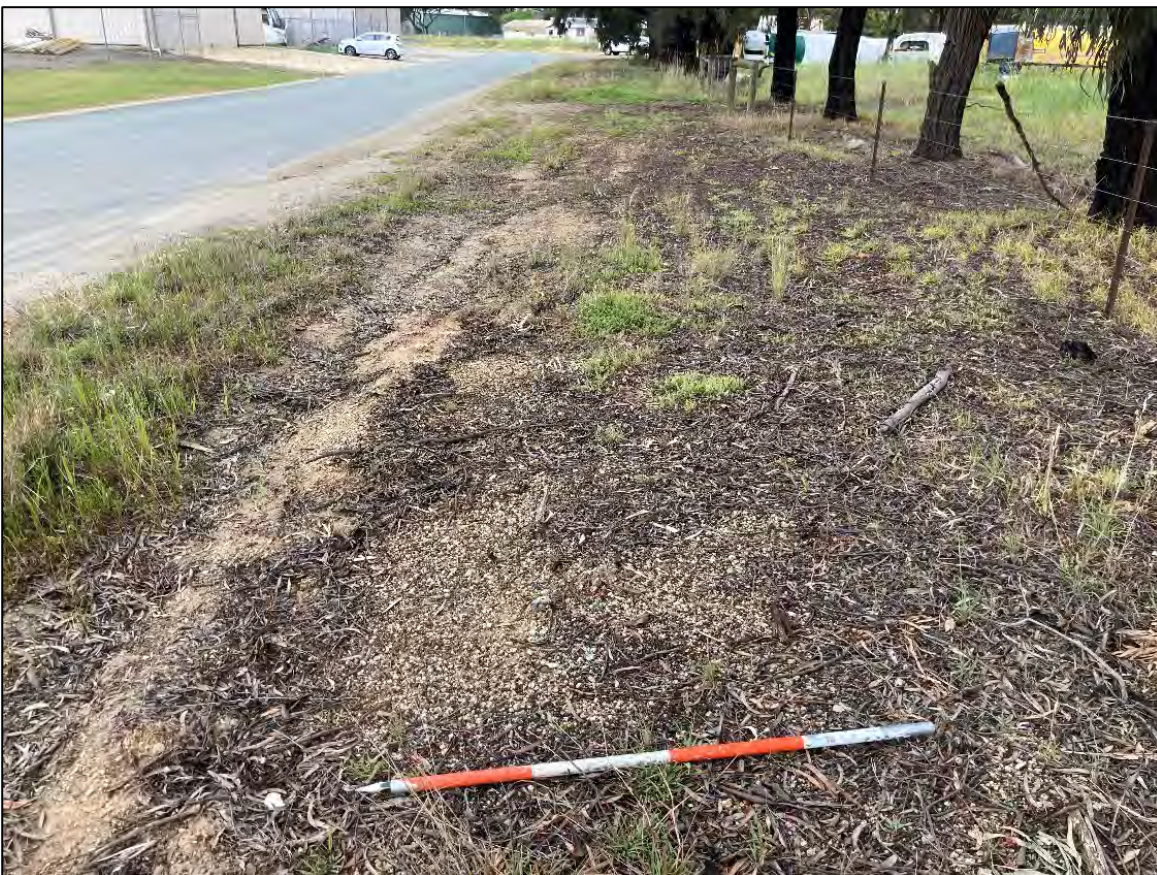
**Photo 1: Site conditions, Needham St roadside, imported gravel fill. Good GSV. Photo: D.Wall, 2023**
