# Proposed Numurkah Flood Mitigation Project Stage 1 - Levee Construction, Numurkah, VIC 3636

Cultural Heritage Management Plan No: 19665

**Date:** 8/3/24

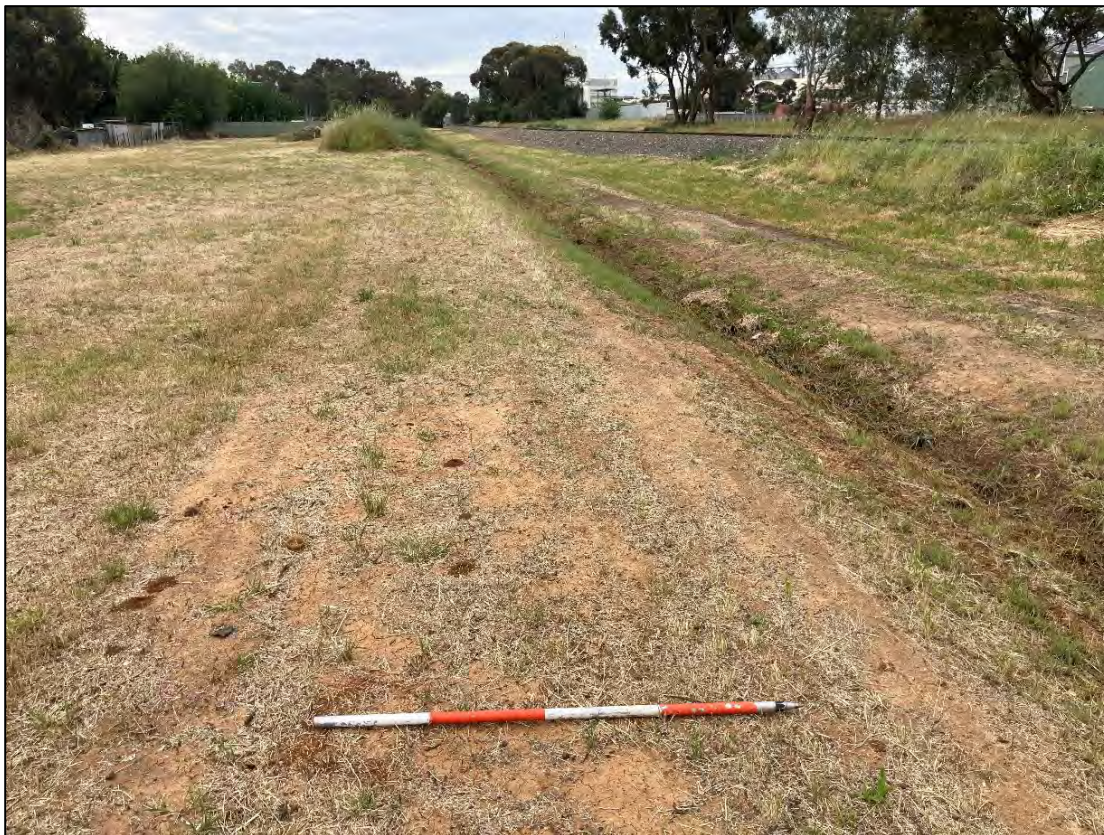
**Photo 2: Site conditions along railway corridor, evidence of trenching/drain construction, exotic dominated ground cover. Fair GSV. Photo: D.Wall, 2023.**

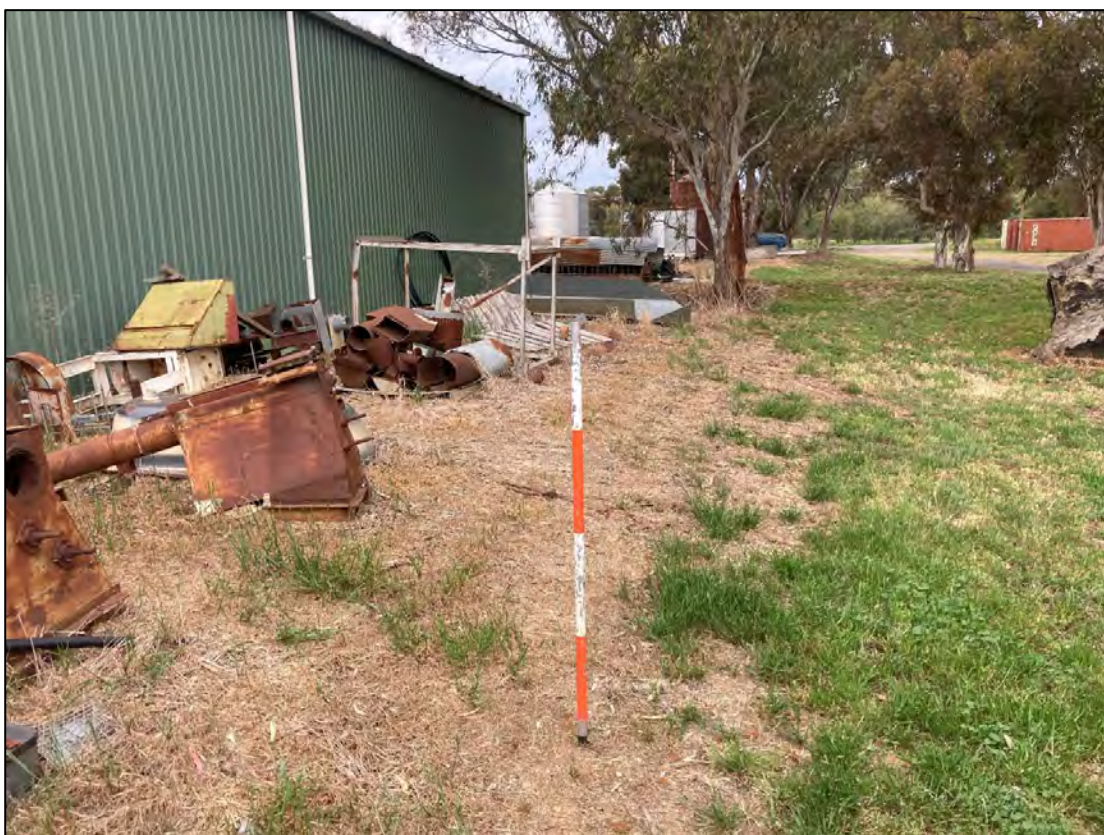
**Photo 3: Site conditions, existing building/infrastructure. Fair GSV. Photo: D.Wall, 2023.**

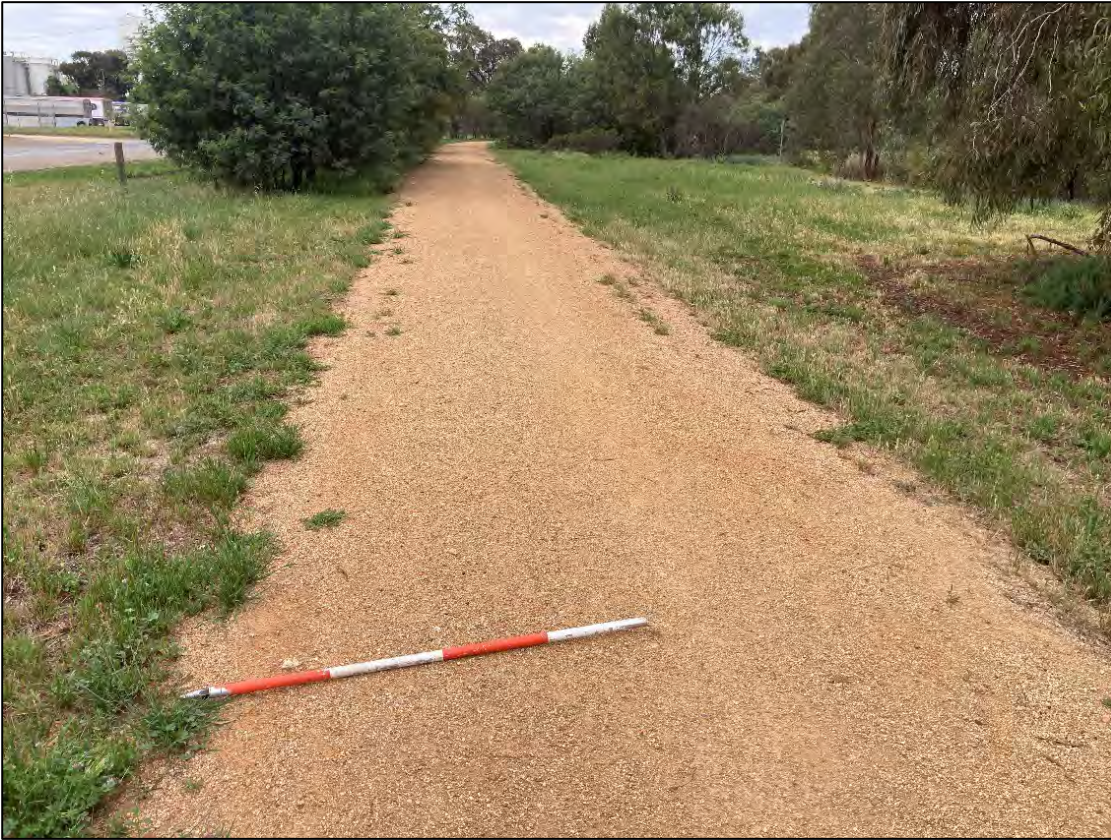
**Photo 4: Site conditions, existing walking/access track, imported fill. Good GSV. Photo: D.Wall, 2023.**

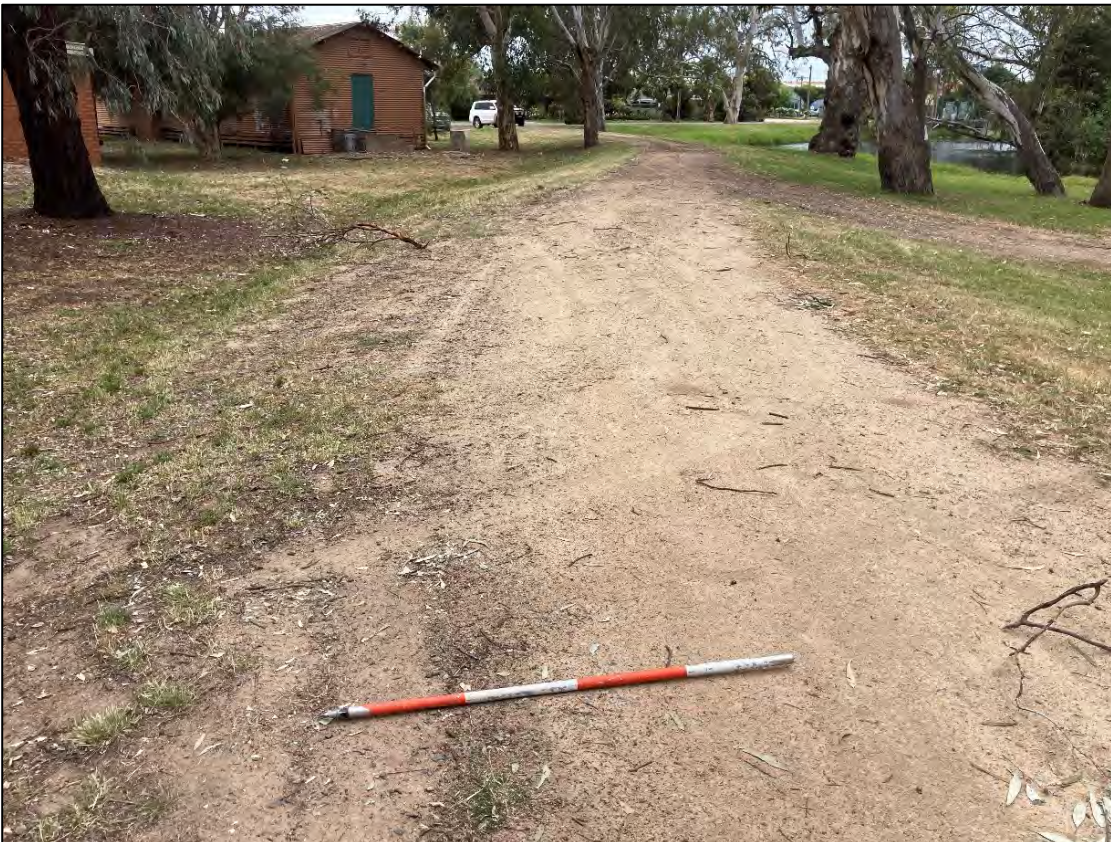
**Photo 5: Site conditions, existing walking/access track, imported fill. Good GSV. Photo: D.Wall, 2023.**

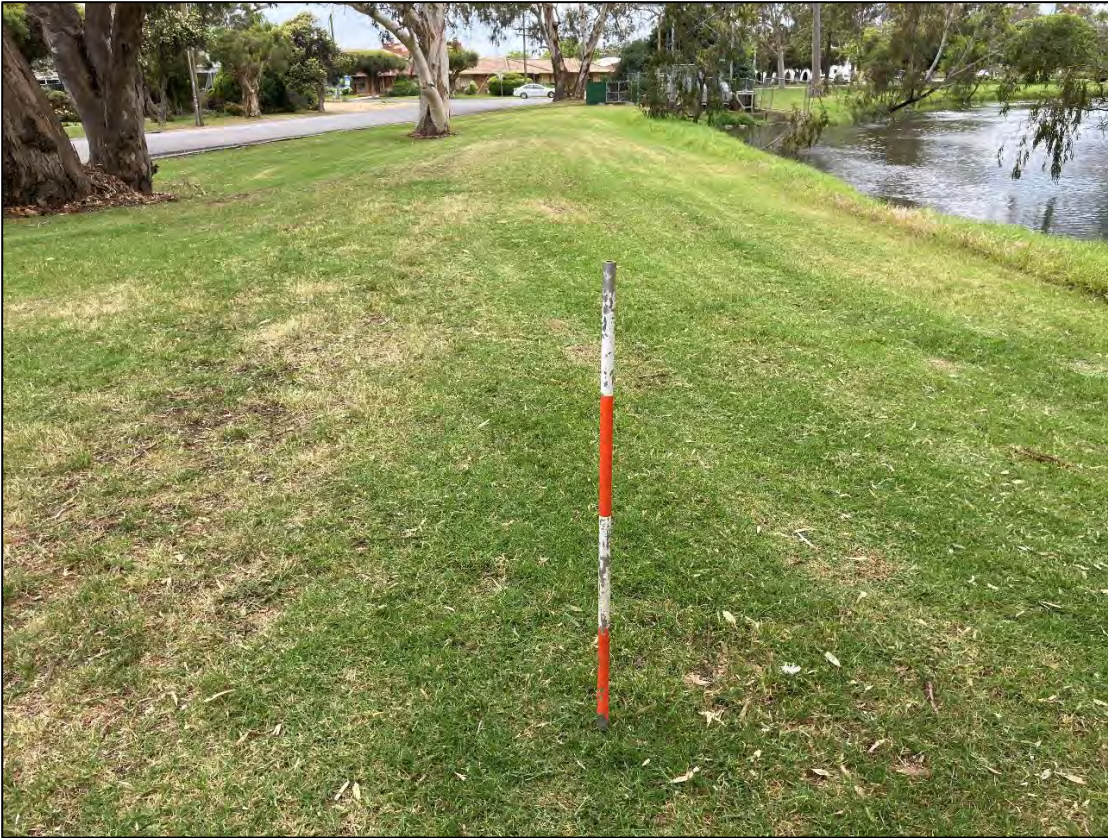
**Photo 6: Site conditions along creek corridor, exotic dominated ground cover. Poor GSV. Photo: D.Wall, 2023.**

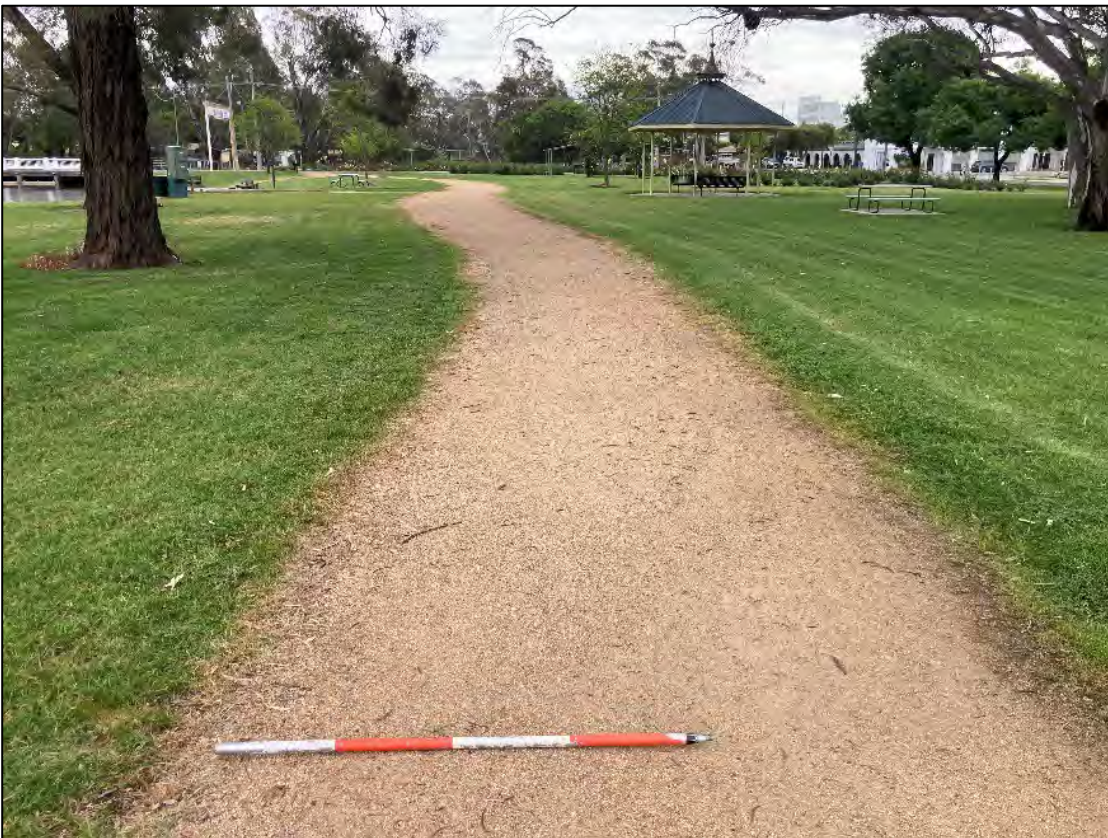
**Photo 7: Site conditions along foreshore walking track/park, imported gravel fill, exotic dominated ground cover. Good GSV. Photo: D.Wall, 2023.**

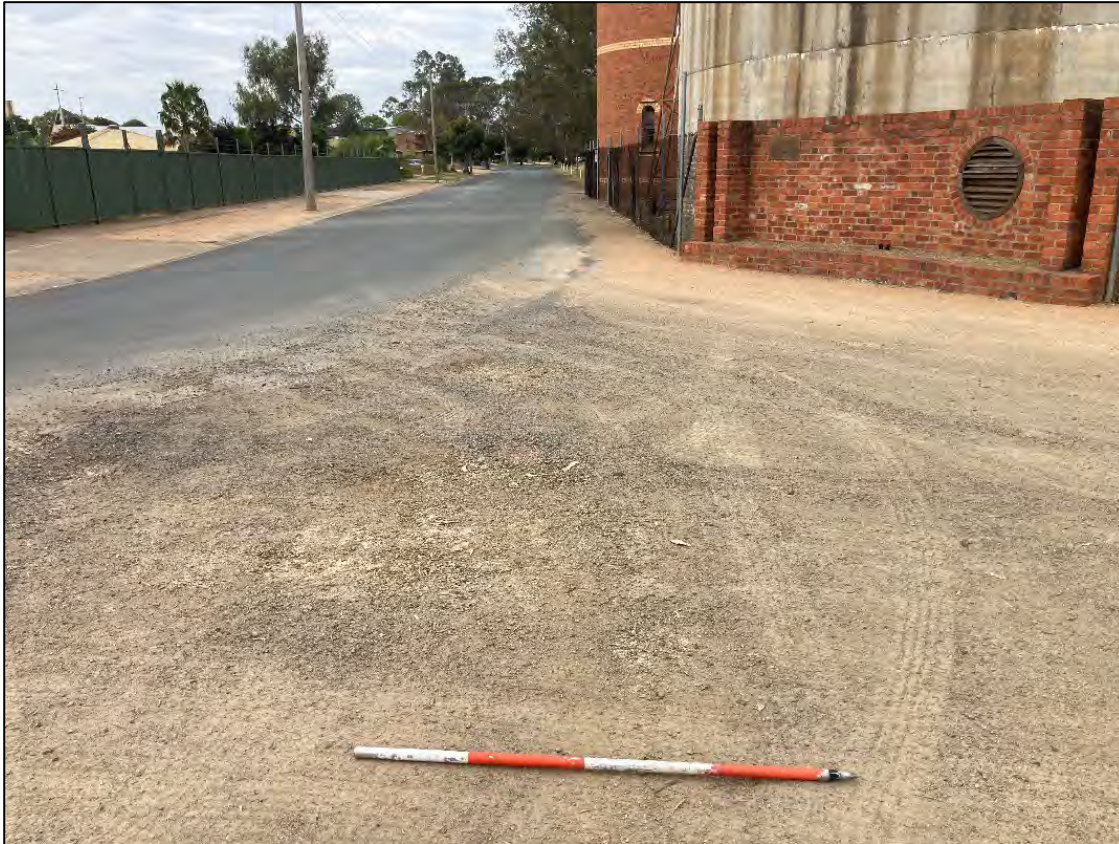
**Photo 8: Site conditions near old water tank off Gray St, imported gravel fill. Good (Gravel) to Zero (Asphalt) GSV. Photo: D.Wall, 2023.**

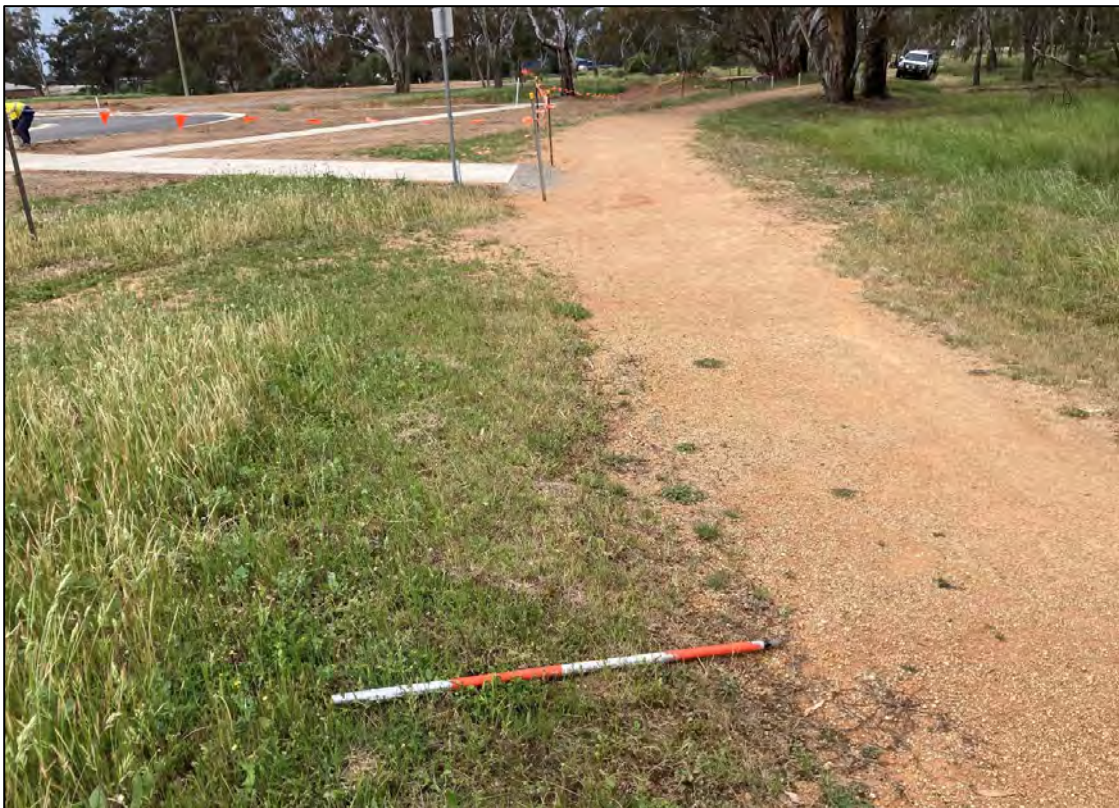
**Photo 9: Site conditions, existing walking track, imported gravel fill. Good (Gravel) to Poor (Exotic grasses) GSV. Photo: D.Wall, 2023.**

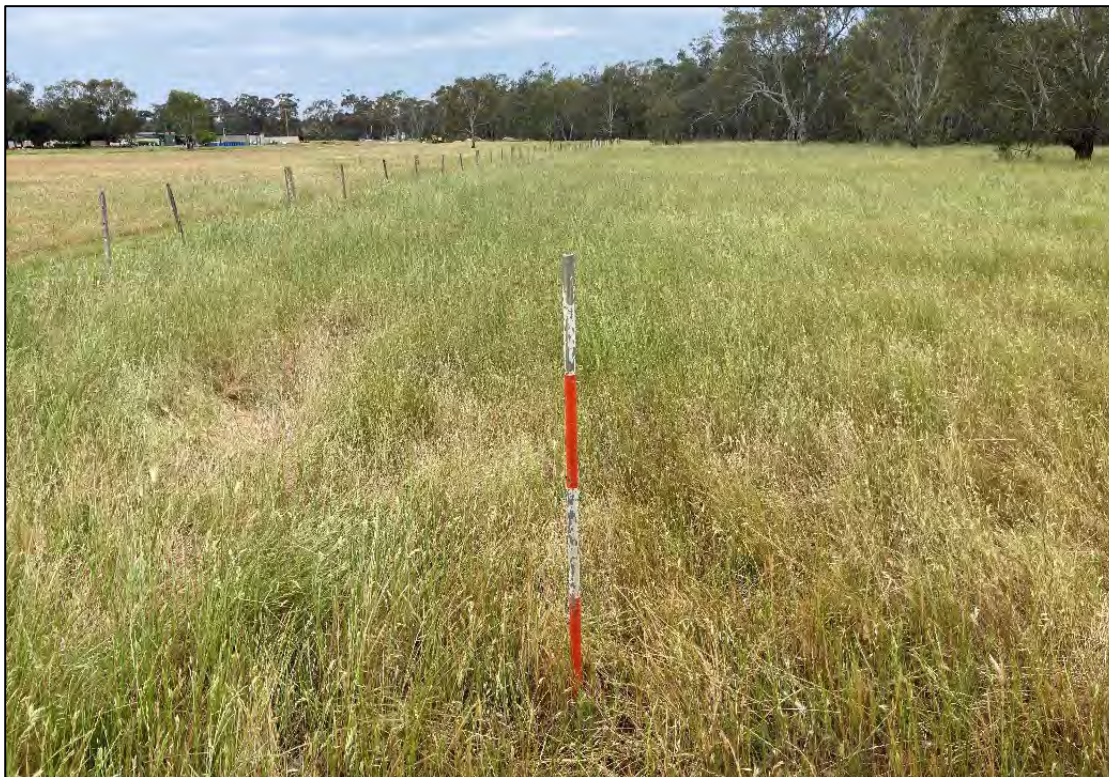
**Photo 10: Site conditions, open paddock, minimal evidence of disturbance, recommended monitoring per Management conditions 4 & 5. Poor GSV. Photo: D.Wall, 2023.**
